# **NASA's Recommendations to Space-Faring Entities:** How to Protect and Preserve the Historic and Scientific Value of U.S. Government Lunar Artifacts

**Release: July 20, 2011**

**NASA'S RECOMMENDATIONS TO SPACE-FARING ENTITIES: HOW TO PROTECT AND  
PRESERVE HISTORIC AND SCIENTIFIC VALUE OF U.S. GOVERNMENT ARTIFACTS**

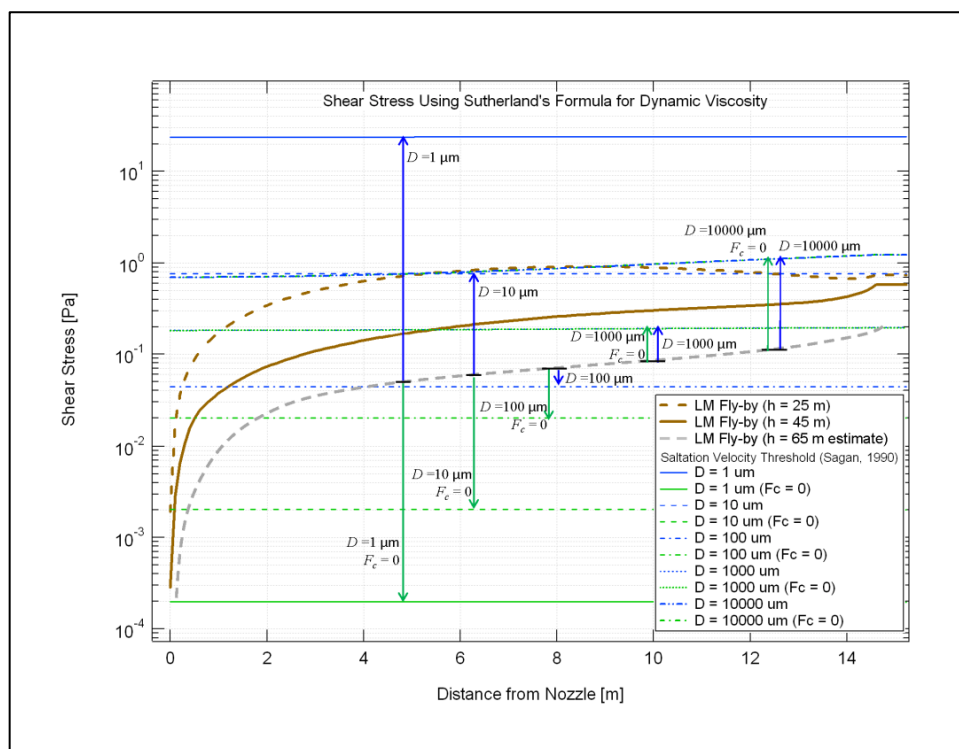
Figure 11: Shear stress generated by a rocket exhaust plume and shear stress levels required to mobilize various sizes of lunar soil particles.

shown in Figure 11. At that altitude, although the fine-sand sized particles do begin to move, they do not experience sufficient lift and will not travel any appreciable distance before falling back to the surface. Also, these particles do not have enough optical density to be seen moving. Only clouds of particles smaller than about  $10\ \mu\text{m}$  should be visible to the crew from any appreciable height. The saltating motion of those fine-sand sized particles, however, mechanically disturbs the dust particles ( $<10\ \mu\text{m}$ ), which can overcome the cohesion that had held them to the surface. Once knocked loose, the dust can then be lifted by the plume, accelerated to high velocity, and seen as a dust sheet by the crew. Without the saltating disturbance of fine-sand sized particles, the plume could not directly move the dust-size particles until the LM is below about 25m. The saltating disturbance may explain why the Apollo 12 crew saw dust blowing from such a high altitude.

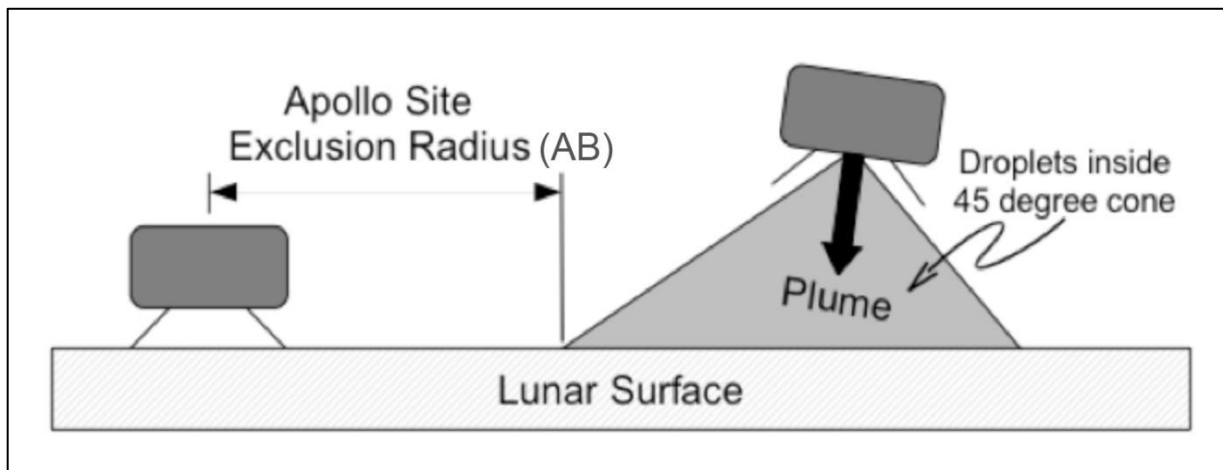
Figure 12: Illustration of plume droplet cone.

*The purpose of this recommendation is to keep the lunar heritage sites from being contaminated with propellant residue that is potentially toxic to humans and/or damaging to Apollo hardware (e.g., corrosive). Studies have shown that droplets large enough to be of consequence (larger than one micron in diameter) of unburned/residual propellant from spacecraft rocket motors are confined to within 45 degrees of the engine thrust axis when the rocket is operated in a vacuum environment. Therefore, adherence to this constraint will*

*ensure that adverse effects from the deposition of propellant droplets upon the Apollo artifacts will not occur.*

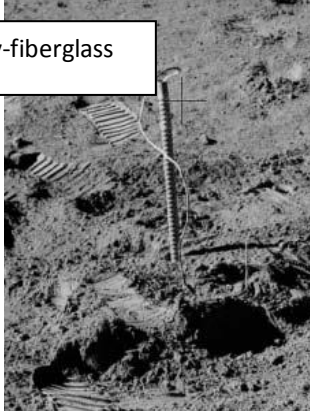
**Probes:** epoxy-fiberglass

**Figure B7 – Heat Flow Experiment**

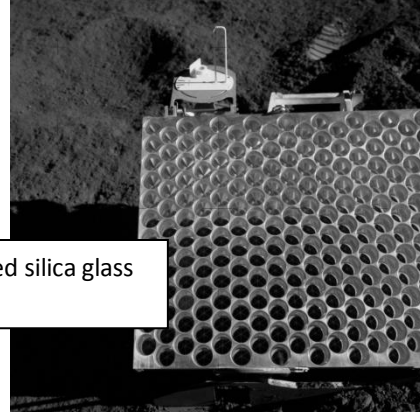
**Reflectors:** fused silica glass

**Figure B8 – Laser Ranging Retroreflector**
